TURTLE STREET BEACH RESORT, CURTIS ISLAND (EPBC 2015/7585) – RESPONSE TO REQUEST FOR ADDITIONAL INFORMATION

Turtle Street Beach Resort: Integrated Water Management Design Report

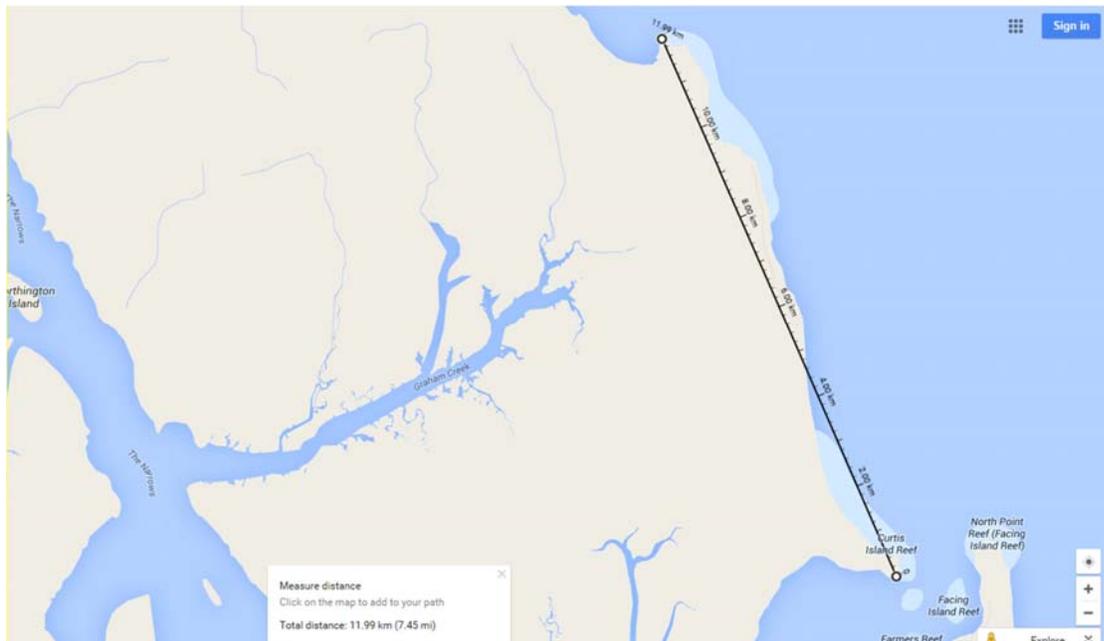
Figure 1. Location of resort node relative to South End (Source: Google Maps, 2016).

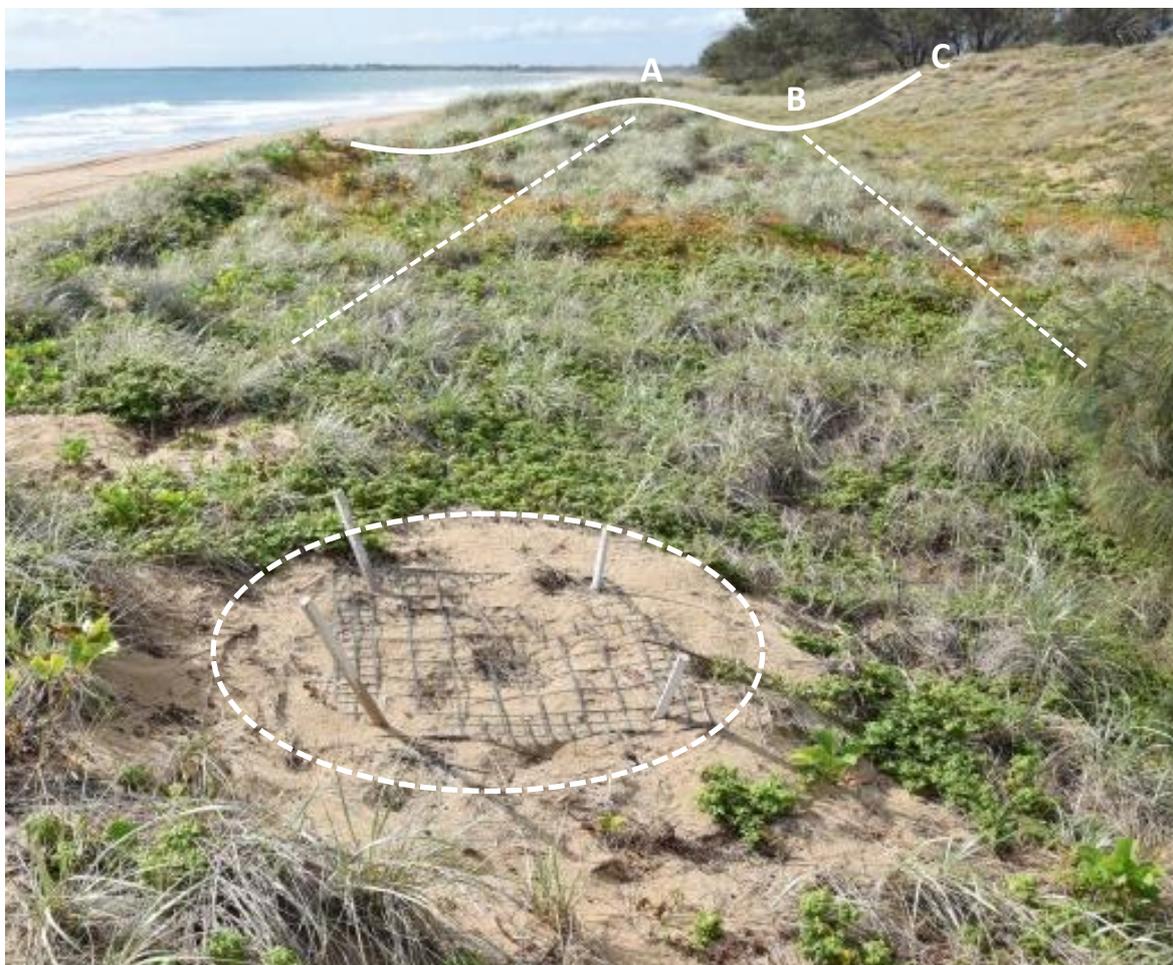
Figure 2: Beach profile at Curtis Island showing A) primary dune B) swale C) secondary dune. Dashed lines show path taken by survey team during monitoring to ensure capture of clutches within the swale. Dashed circle shows clutch protected by mesh to protect incubating eggs from predation by the local wild dog population.

On Curtis Island one team member walked on top of the primary dune (A; **Figure 2**) as the other walked in the swale (the hollow between ridges, B; **Figure 2**) between the primary and the secondary dune (C; **Figure 2**). This approach ensured detection of emerged clutches located in the swale section of the beach profile. On Facing Island the entire supra-tidal zone (area above the high tide mark) was surveyed for evidence of hatchling emergences.

The feral animal population on Curtis Island is currently managed by the QPWS. Clutches are identified following oviposition and covered with a mesh (**Figure 2**) designed to prevent dogs from digging up clutches during incubation and wide enough to allow hatchlings to emerge and migrate toward the ocean.

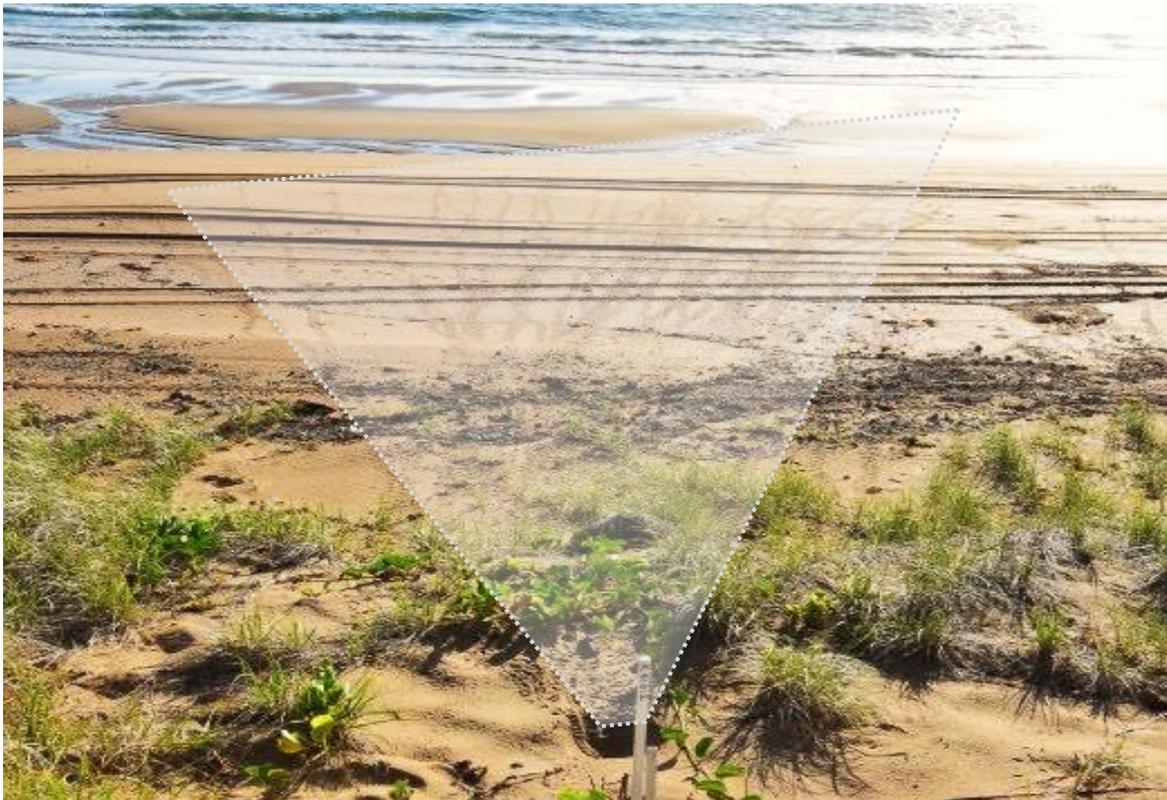
Figure 5: Emergent hatchling fan (within the shaded area) from a clutch located on the primary dune of Curtis Island, showing successful seaward orientation.

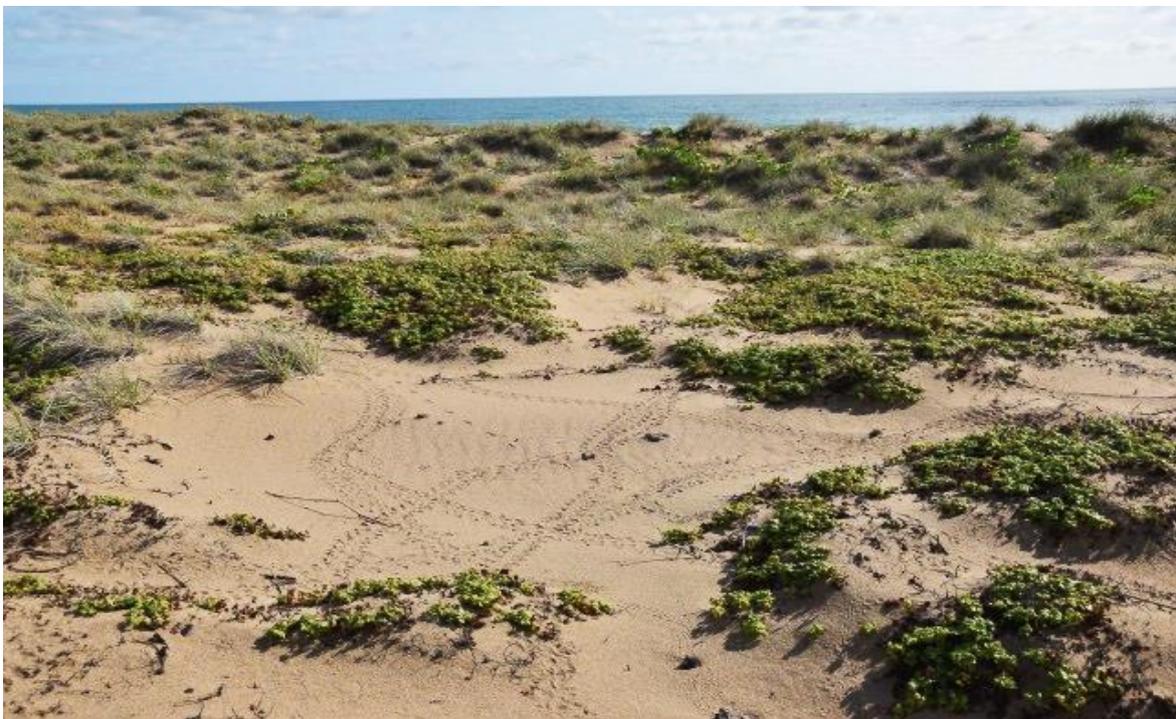
Figure 6: Tracks of hatchlings in the swale area of the beach profile at Curtis Island. The location of the clutch from which these hatchlings emerged was not identified.

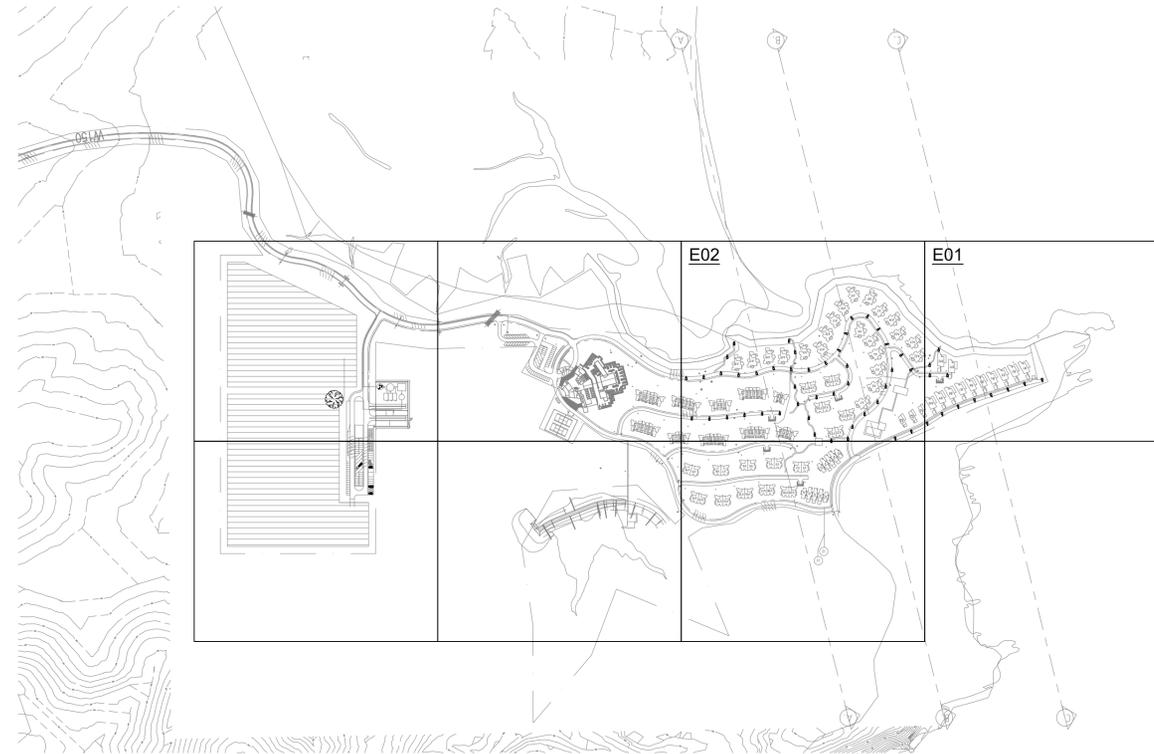
DRAWING LABELLING LAYOUT 1:5000

NOTE:
 E01 & E02 HAVE BEEN PROVIDED AS EXAMPLES OF LIGHTING APPROACH TO
 BE USED THROUGHOUT THE DEVELOPMENT. SUBJECT TO APPROVAL A FULL
 EXTERNAL LIGHTING LAYOUT WILL BE PROVIDED.

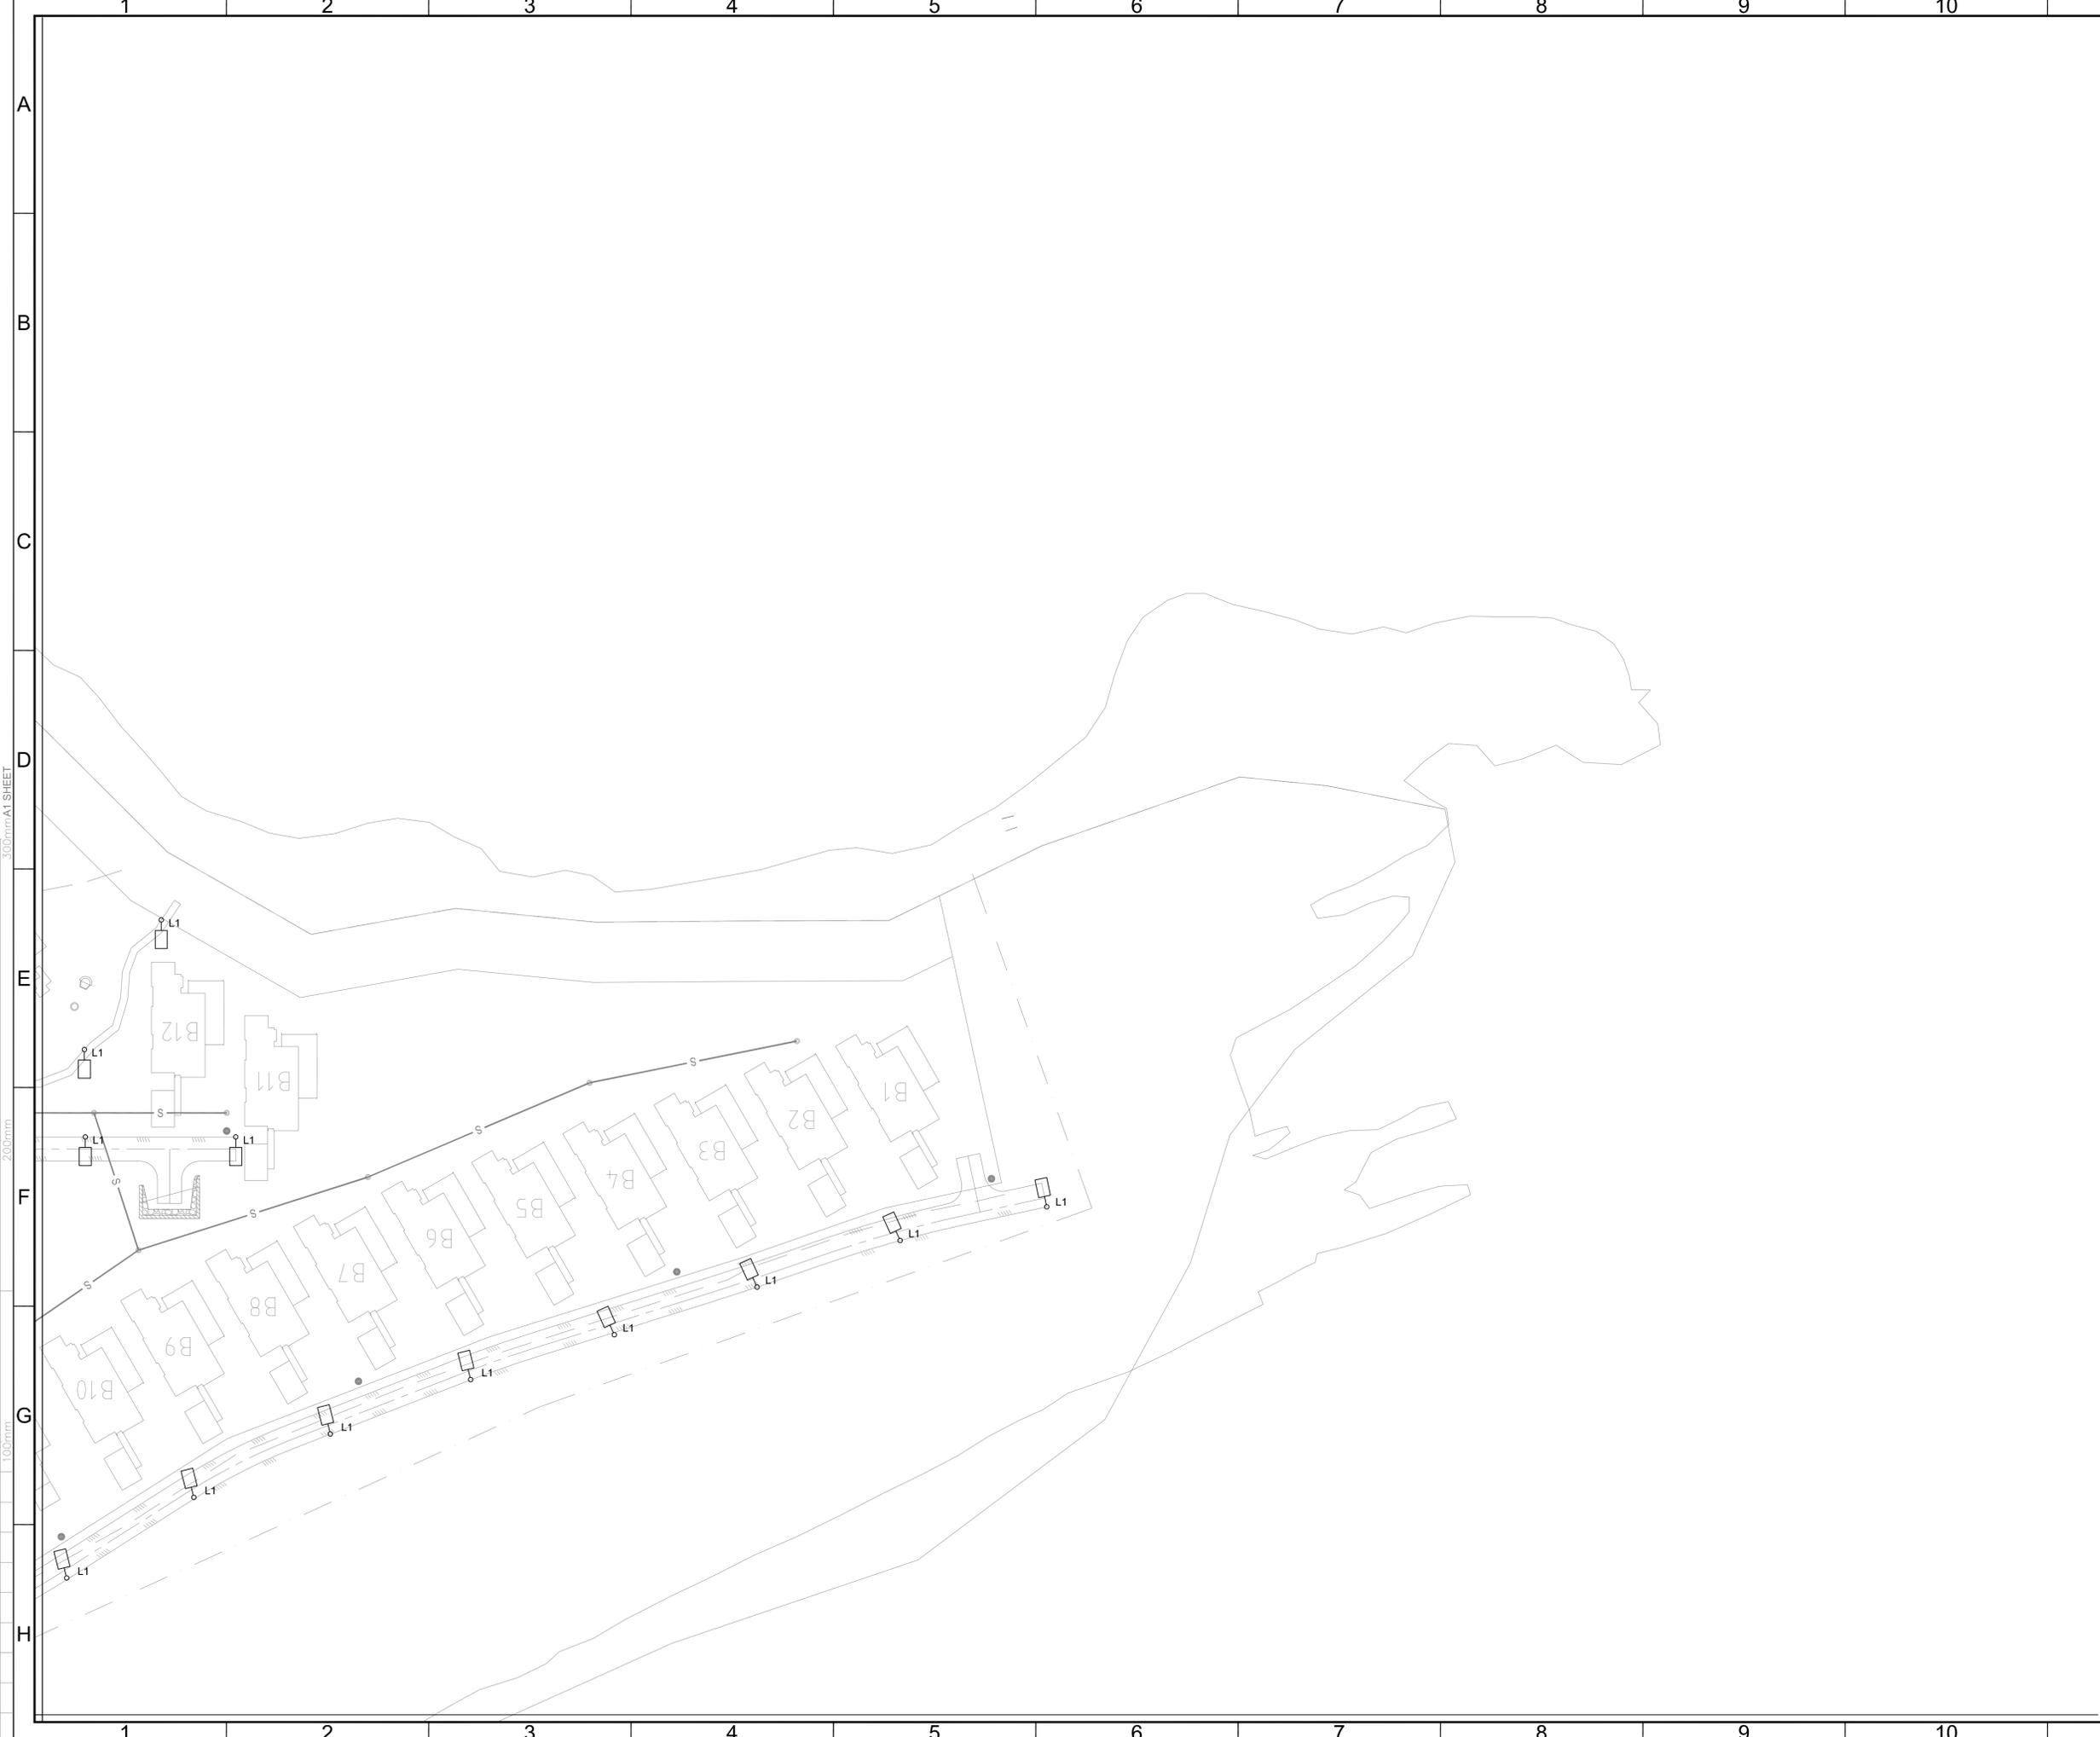
- DO NOT SCALE FROM DRAWINGS. ALL DIMENSIONS & LEVELS TO BE VERIFIED ON SITE BEFORE MANUFACTURE AND/OR CONSTRUCTION.
- L1 LIGHT SHOWN AT 25m SPACING.

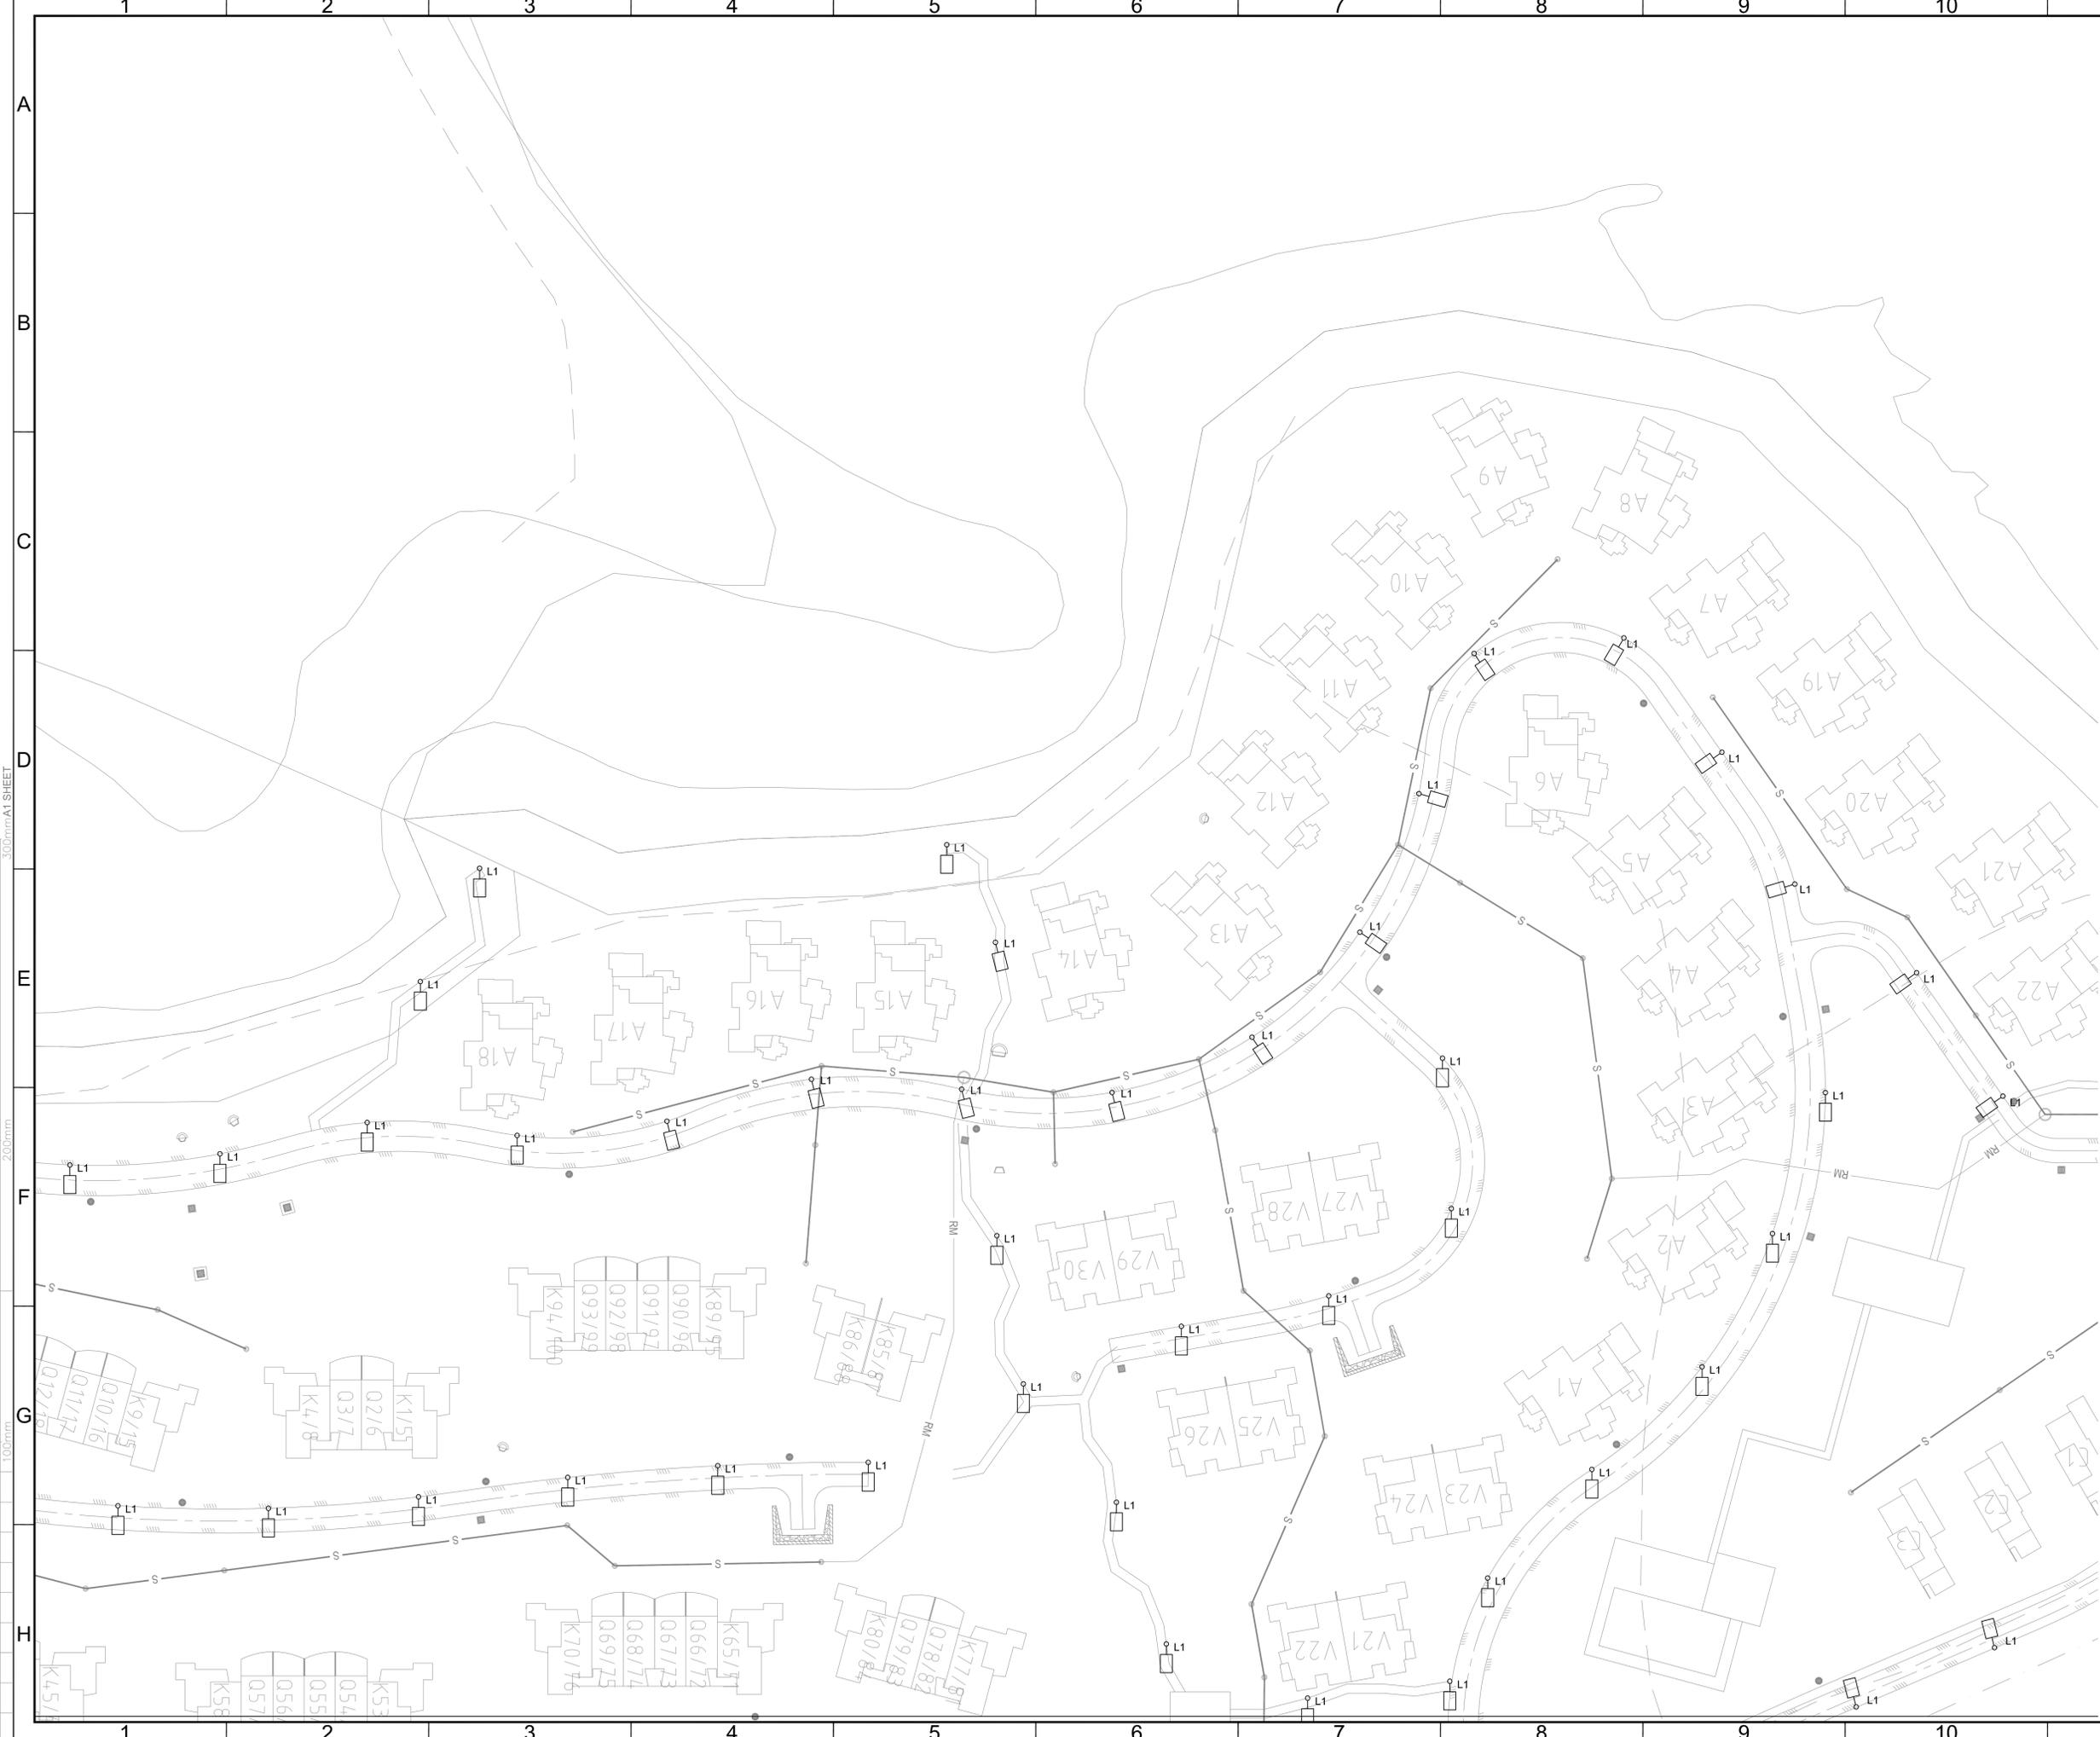
- DO NOT SCALE FROM DRAWINGS. ALL DIMENSIONS & LEVELS TO BE VERIFIED ON SITE BEFORE MANUFACTURE AND/OR CONSTRUCTION.
- L1 LIGHT SHOWN AT 25m SPACING.
